Having a Come-Apart: Lessons Learned from Additively Manufactured Hardware Failures

Paul Gradl, Ben Williams, Colton Katsarelis, Gabriel Demeneghi,
Will Tilson, Brian West, David Ellis, Alison Park

National Aeronautics and Space Administration (NASA)

3 November 2022

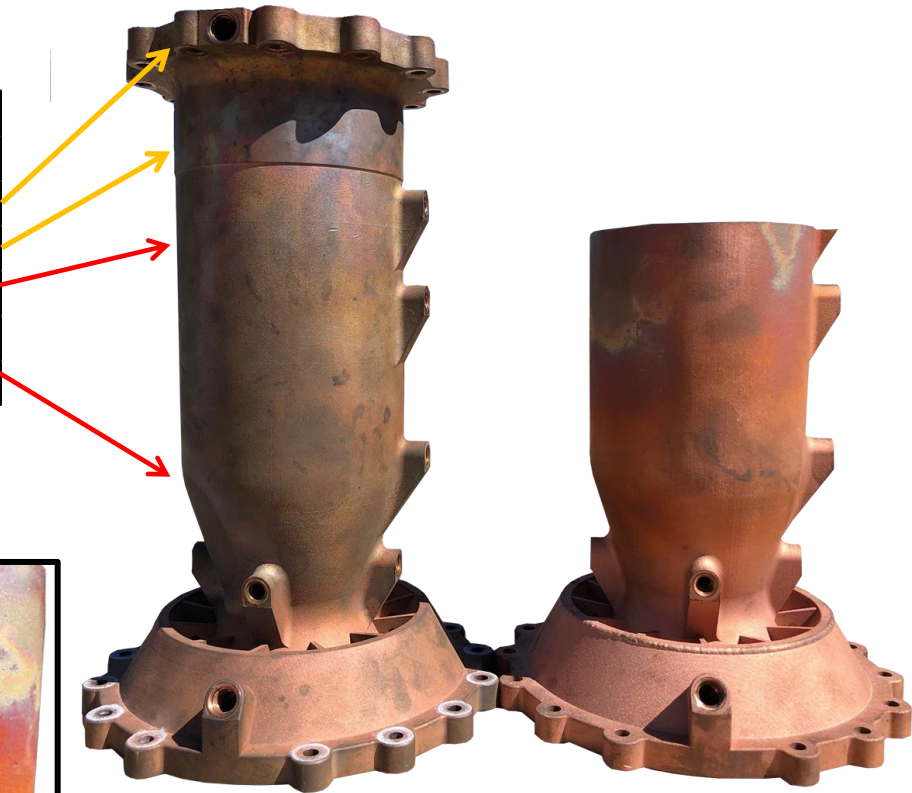
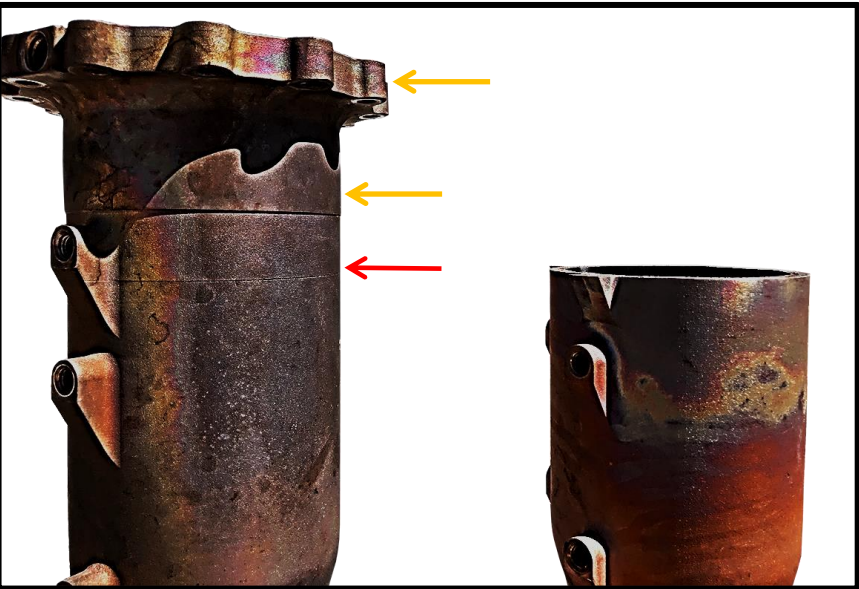
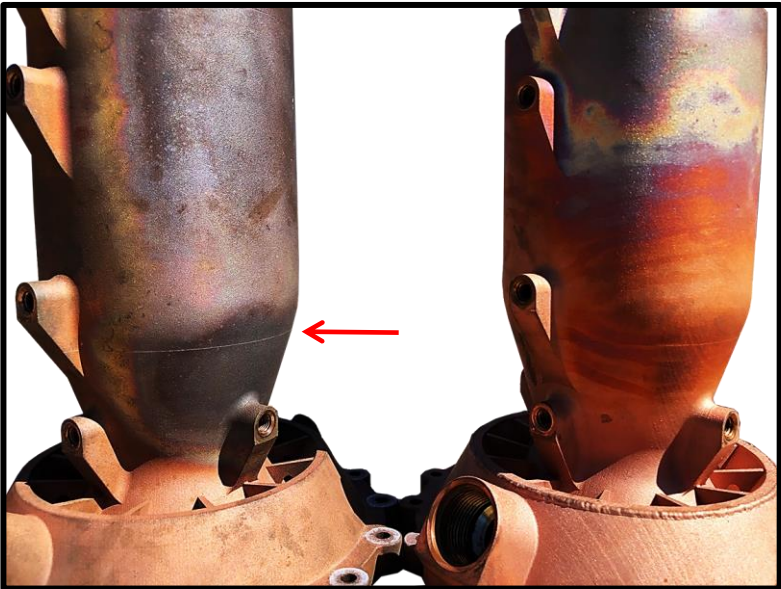
Date	Time	Event	Slice Number	Height (in)	Restart	Exposed to Air?
1/16/2020		Build Completion	8889	14		
1/14/2020	5:10	Power Outage	8764	13.805	7:01	No active purge, chamber sealed
1/11/2020	14:13	Brownout	8084	12.731	14:25	No active purge, chamber sealed
1/8/2020	17:41	Empty Overflow	6562	10.332	18:47	Exposed to air
1/4/2020	12:48	Empty Overflow	2968	4.674	13:14	Exposed to air
12/30/2019		Build Start	0	0

Color adjusted in photos to highlight witness lines

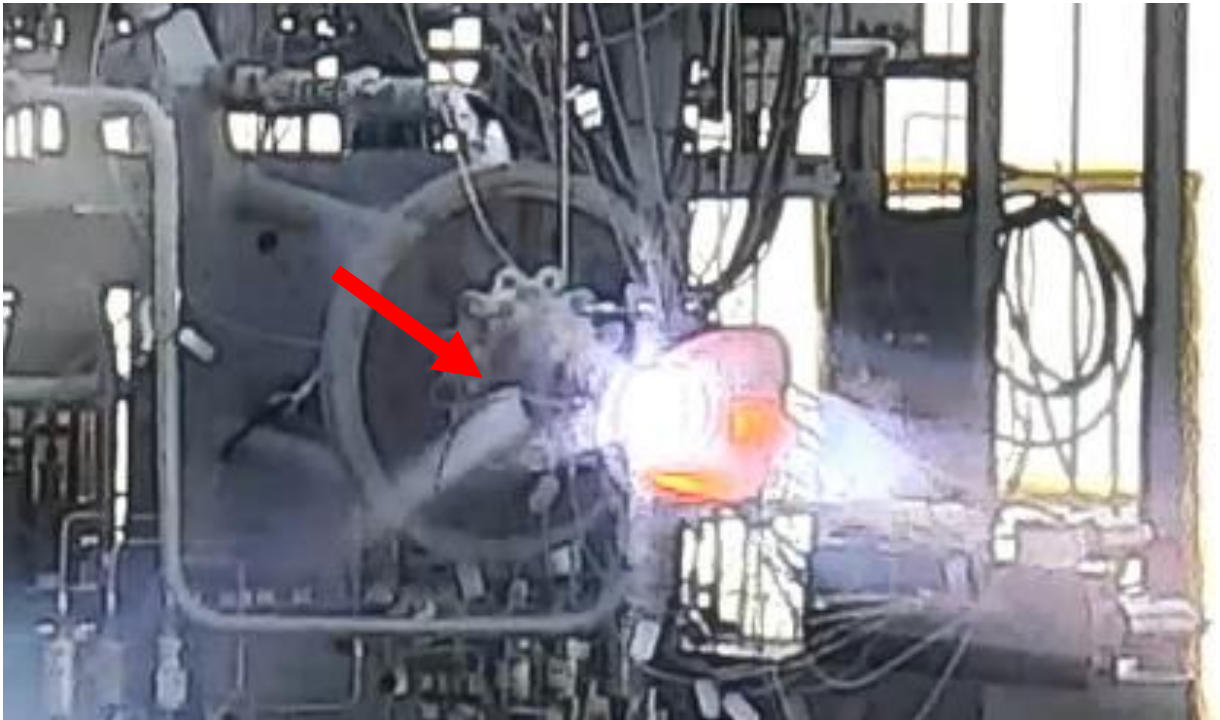
PK129 Test 18

C2 - separated chamber (9 starts)

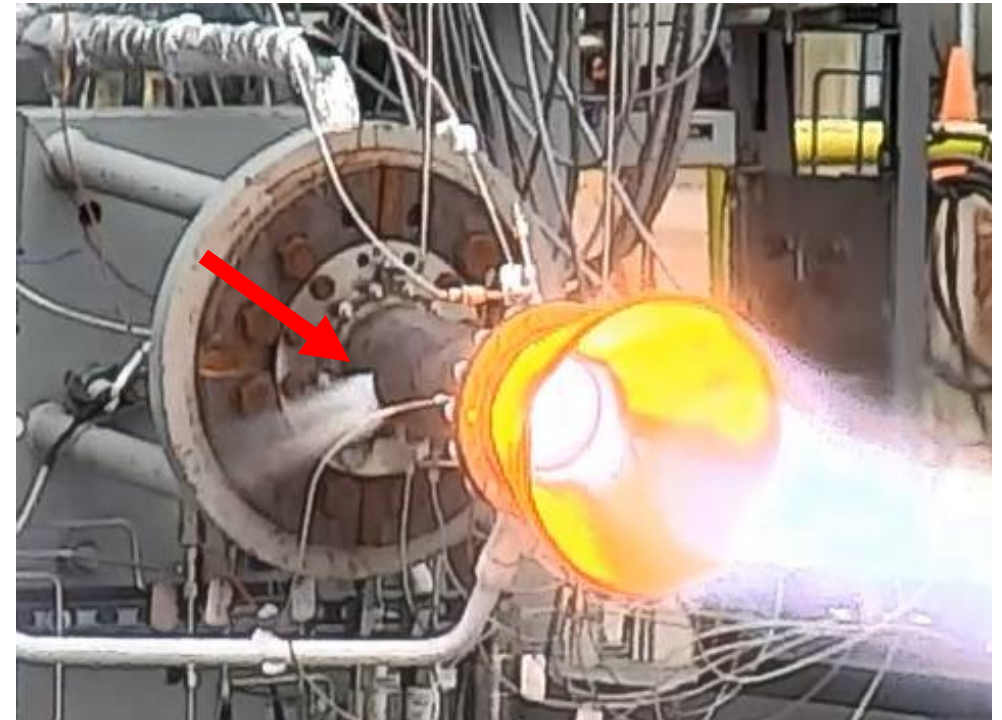
PK129 Test 13

C3 - 51 start chamber (full life cycle)

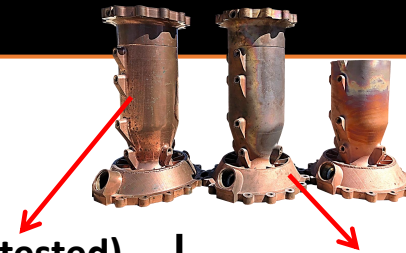
- Unpolished external surfaces.
- Top (power outage) and bottom (powder overflow) witness lines did not appear to have many detrimental defects.
- Middle witness line on chamber 1, there were some large lack of fusion defects that appeared to line up with the restart line.
- Chamber 3 – no defects visible at the surface beyond the crack that had already developed after test.

Middle witness line: C1 (untested)
Surface was polished using CMP

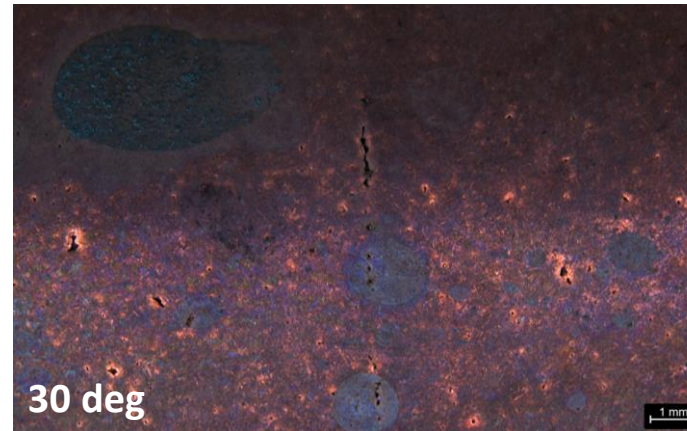
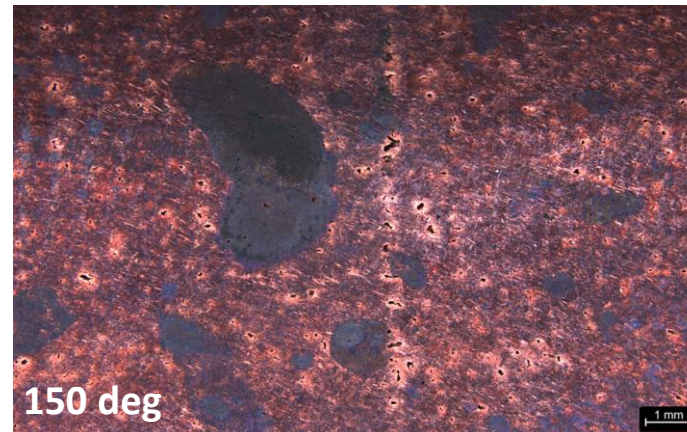
Middle witness line: C3 (51 starts)

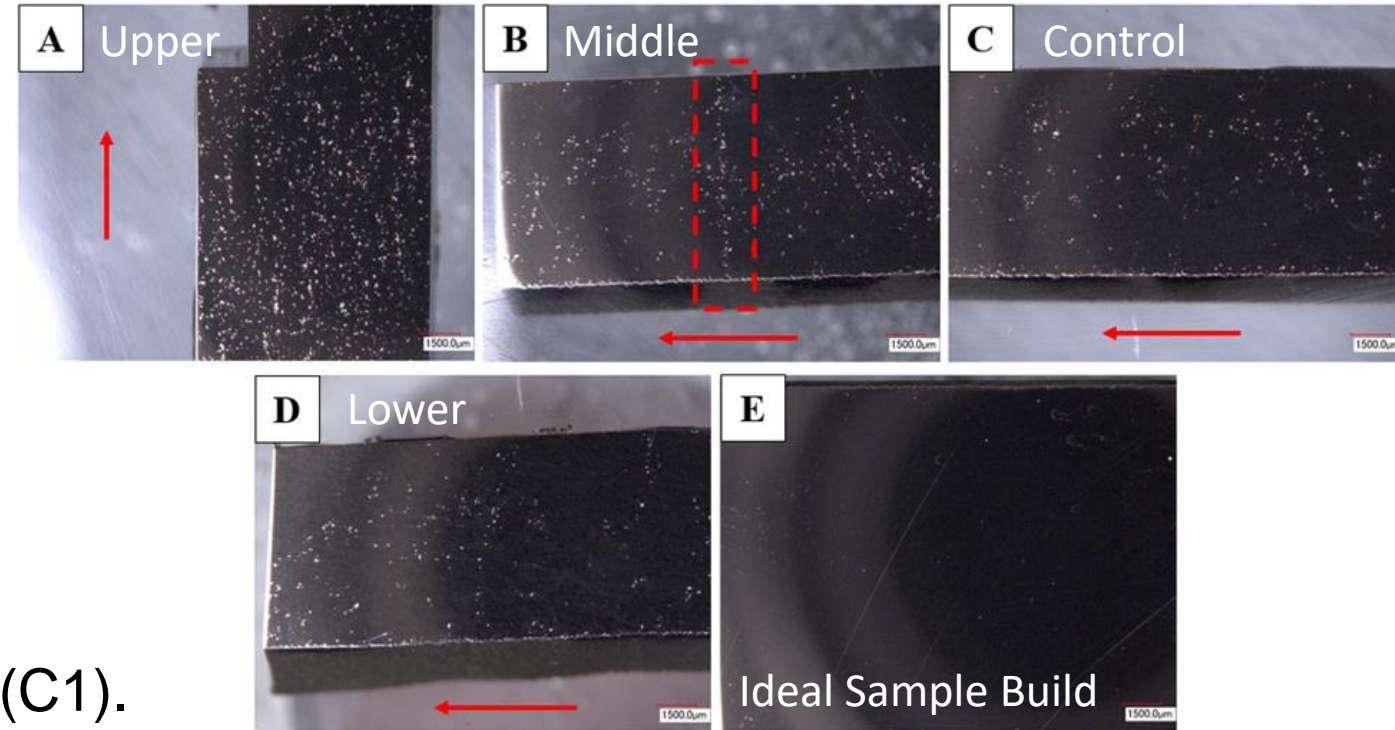
Label	Section	Porosity
A	Upper Witness Line	0.748%
B	Middle Witness Line	1.906%
C	Control Section	0.511%
D	Lower Witness Line	1.743%
E	Tensile Bar	0.006%

- Samples taken from un-tested chamber (C1).
- Tensile bar built separately as part of investigation.
- Proper HIP of chambers was confirmed.
- Porosity is evident throughout samples.
- Clear congregation of porosity around witness lines.
- Porosity reduces load bearing capacity (reduced area) and can act as stress concentrators/crack initiators.

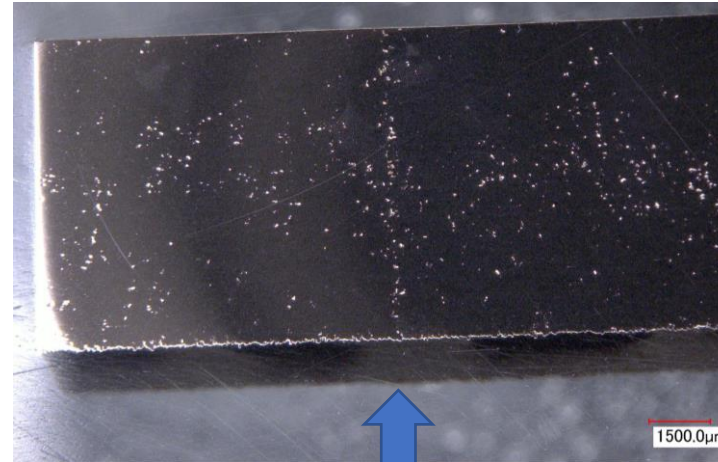
C1 (Leaked), Middle Witness Line

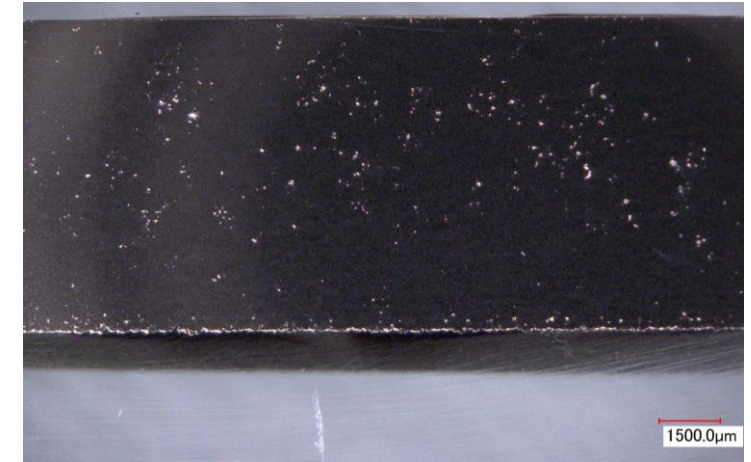
C1 (Leaked), Chamber Control

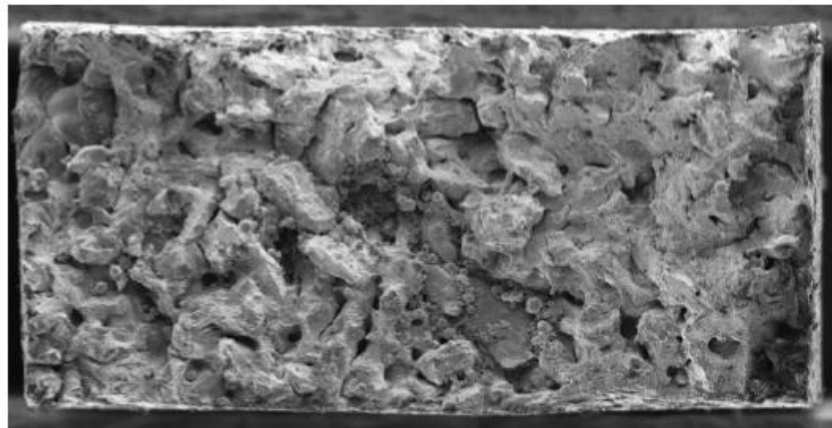
1T1B

- Granular fracture surface, indicating a brittle fracture
- Irregular shape porosity, indicating lack of fusion

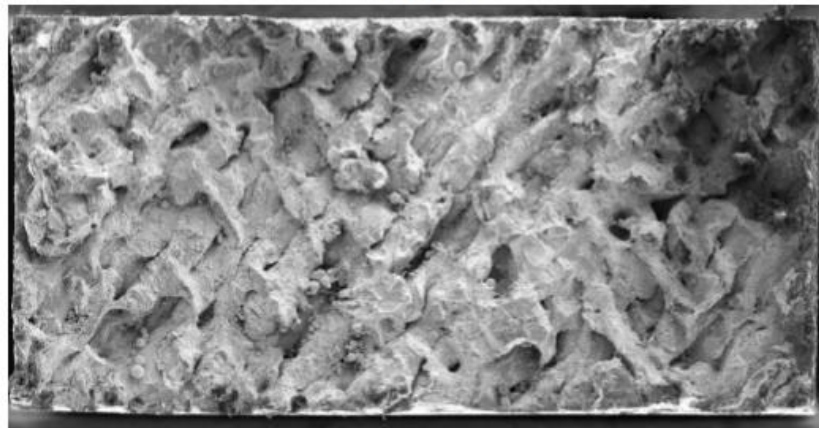
1T2B

- Granular fracture surface, indicating a brittle fracture
- Laser scan pattern clearly visible

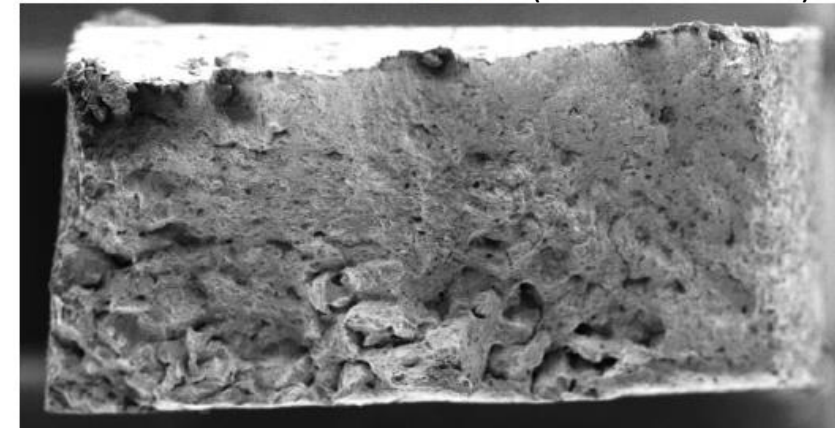
1T3B (Chamber Control)

- Overloaded fracture surface and necking, indicating a more ductile fracture
- Less porosity compared to witness lines

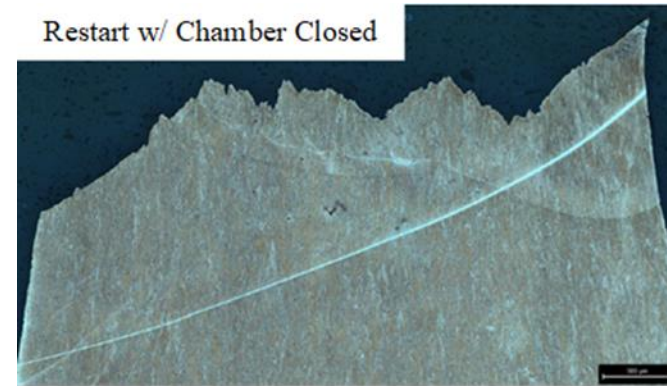
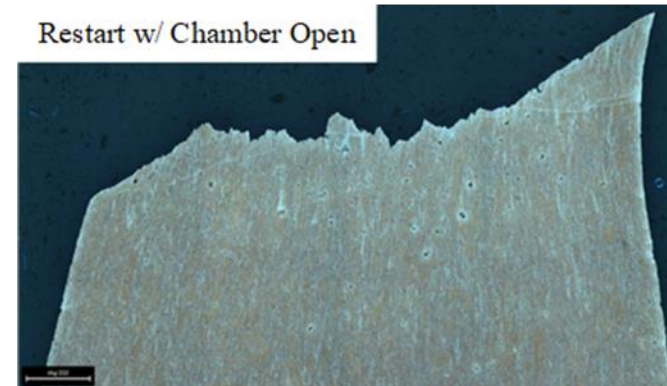
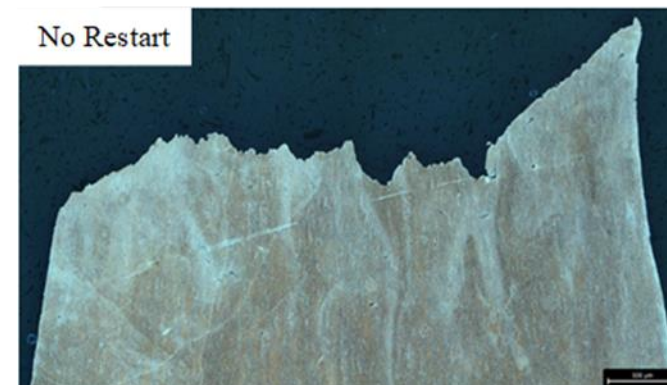
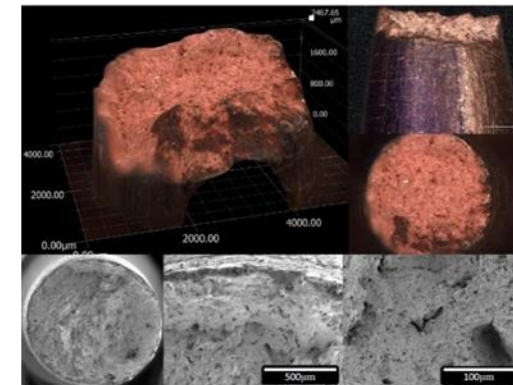
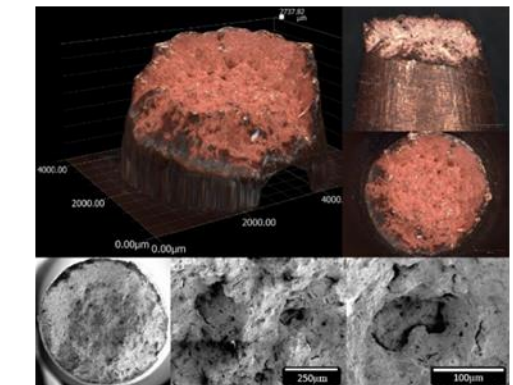
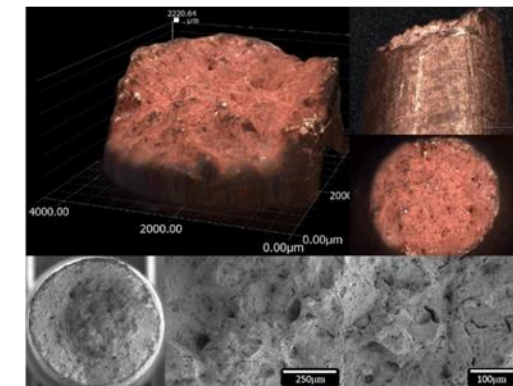
- 3 witness test bars from tensile simulating build stoppages
- Observations:
 - No major differences between fractures
 - Typical cup-cone fracture surfaces common for ductile metals
 - Fracture surfaces had elongated grains
- Conclusions:
 - Similar fractures track with similar properties observed in bars previously

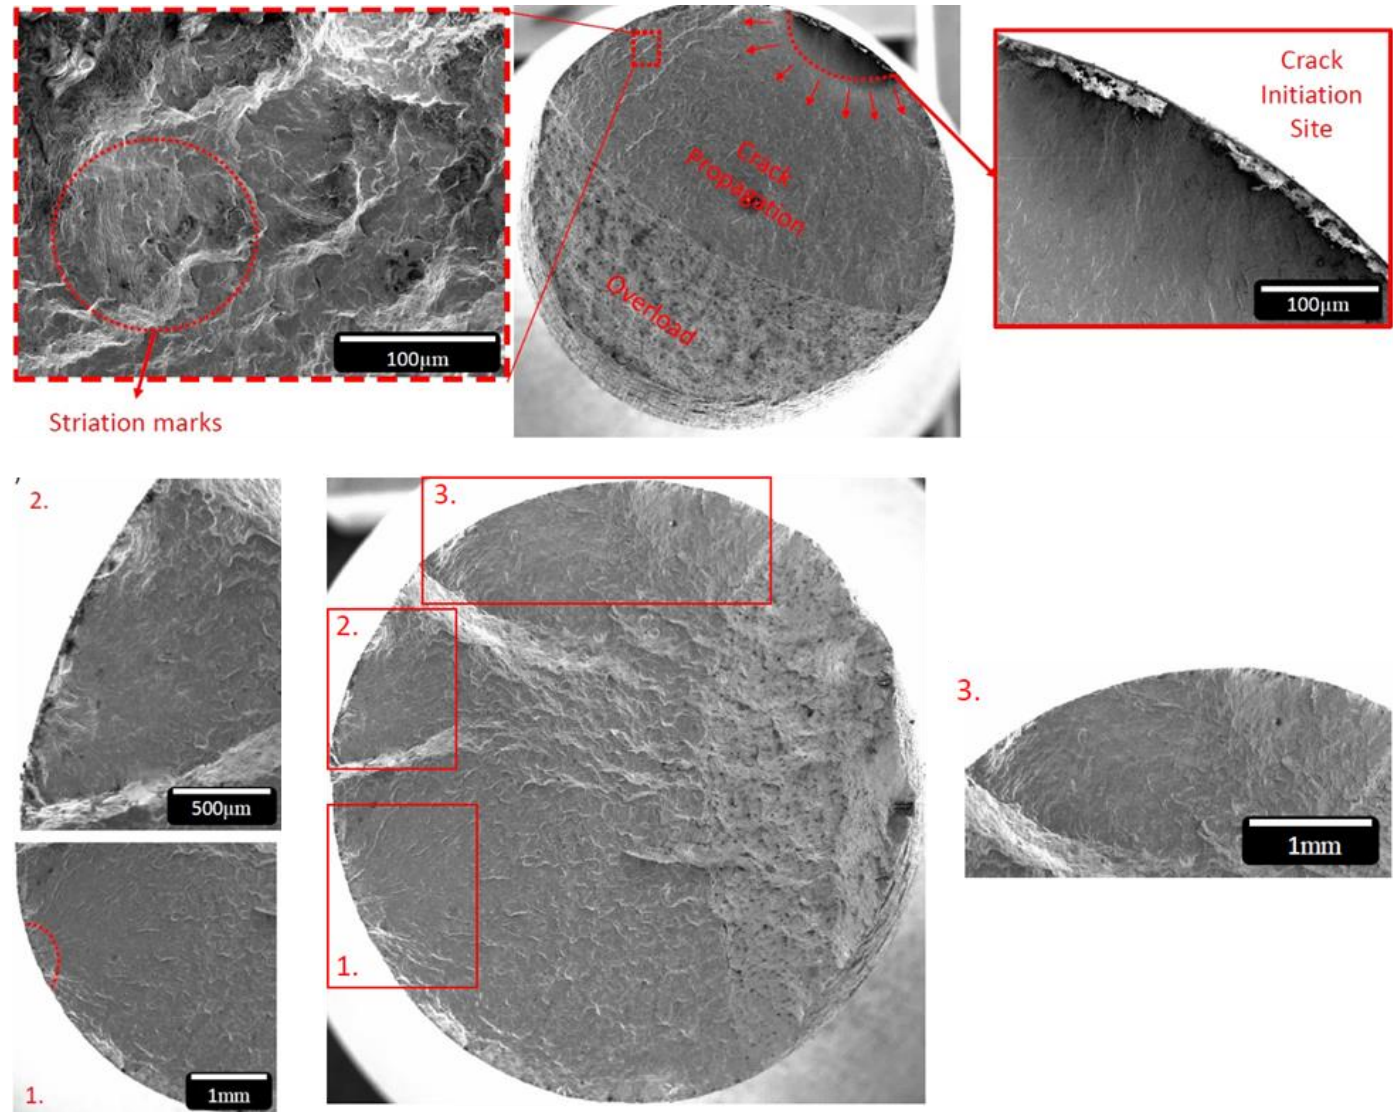
- 3 test bars from LCF
 - Fracture surfaces smeared b/c LCF had fully reversible cycles
 - Closed chamber restart bar never fully fractured
- Observations:
 - Open restart: flat surface before overload failure transition, secondary crack below primary crack
 - No restart: three separate cracks jogged together
